July 28, 2009
Project No: 09147

Review of Prince Andrew School Bryanston, Ontario

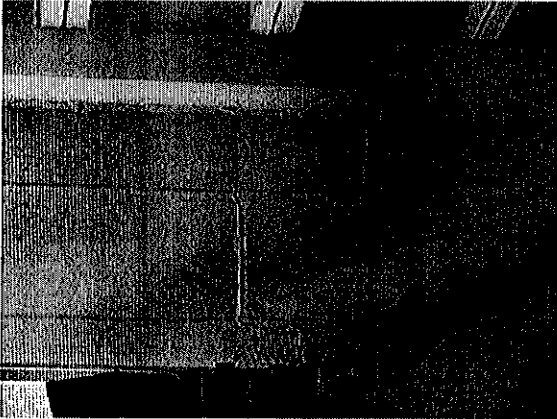
The structure overall appears to be in very good condition. There are cracks in the masonry walls at the interior corners of the classroom window. See **Photo No. 1**. These crack should not pose any problems in the future.

Photo No 1: Crack at Corner

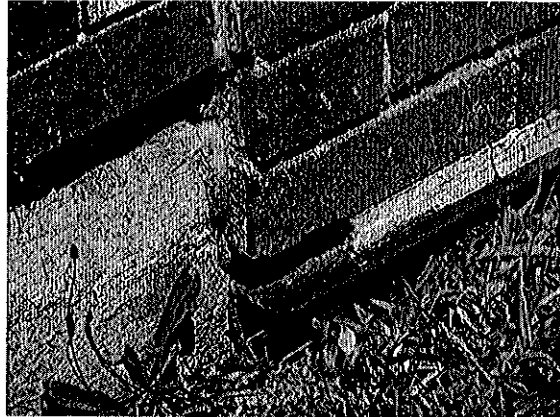
The exterior walls are clad with brick. In some areas at the east elevation, the brick bears on a steel shelf angle bolted to the foundation wall. See **Photo No. 2**. The angle appears to be corroded, however the condition of the anchorage could not be observed.

Photo No 2: Exterior Steel Shelf Angle

There is some concern that the steel brick shelf and the spalling brick could pose a problem if the deterioration progresses. Structurally the building appears to be in excellent condition. Some repairs and maintenance may be necessary in the future however they would be minor. If these items can be budgeted for, then we believe that this building would be a good purchase for the municipality.

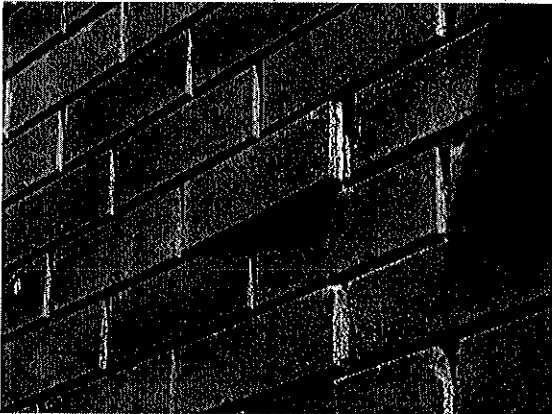
The exterior gymnasium wall is constructed of red brick. Tapping of the brick and visual inspection revealed that the face of the brick is spalling in areas. See **Photo No. 3**.

Photo No 3: Spalling Brick Face
